Scope of Work – Designated Substances Abatement/Procedures

Math Office Renovation P164-24-165

33 Ursula Franklin Street (Building #164) – 33 Ursula Street Toronto M5S 3M1

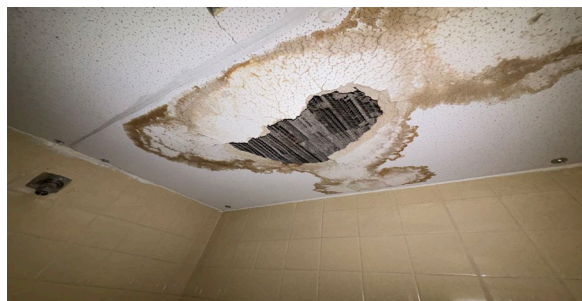
Historic mould contamination was observed at select current project locations. No active water intrusion was observed within the current project locations.

Mould on ceiling tile (washroom 3033A)

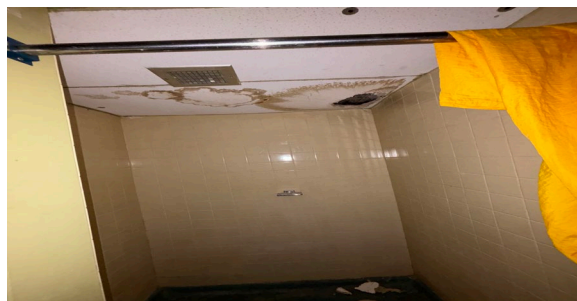
Mould on ceiling tile (washroom 3042A)

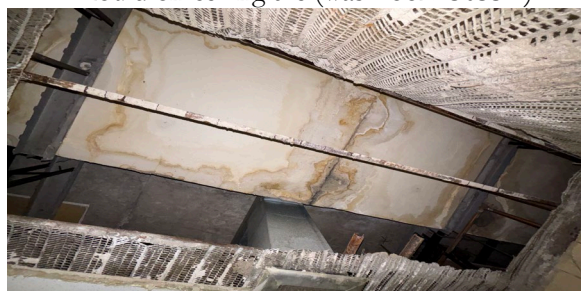
Water-damaged plaster ceiling (washroom 3038A)

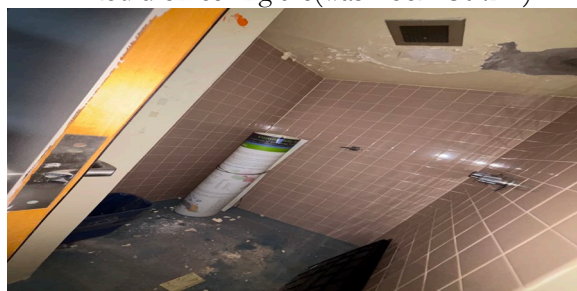
Water-damaged plaster ceiling (washroom 3085A)
