## **DESIGNATED SUBSTANCES AND HAZARDOUS BUILDING MATERIALS ASSESSMENT REPORT**

**Accessibility Upgrades Project  
William G Miller Public School  
60 Bennett Road  
Scarborough, Ontario  
M1E 3Y3**

**Safetech Project Number: 1-3260231**

**Date of Site Work: March 10, 2026  
Date of Issue: March 20, 2026**

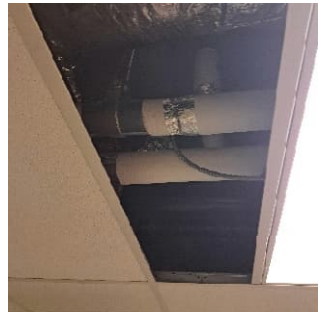
Mechanical Pipe Insulation – Straights	<p>According to the 2020 ECOH report, <b>aircell pipe insulation</b> was previously observed in the subject building. Results of analysis confirmed this material to contain <b>75% Chrysotile</b> asbestos.</p> <p>This building material is not expected to be affected by the accessibility upgrade project.</p>	
Mechanical Pipe Insulation – Fittings (elbows, valves, tees, hangars, etc.)	Pipe fittings were observed to be insulated with fiberglass which is known to be not asbestos-containing.

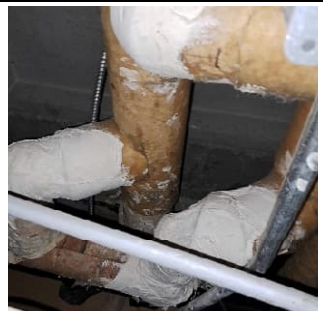
<p>According to the 2020 ECOH report, <b>parging cement on fittings</b> was previously observed in the subject building. Results of analysis confirmed this material to contain <b>50% Chrysotile</b> asbestos.</p> <p>This building material is not expected to be affected by the accessibility upgrade project.</p>	
HVAC Duct Insulation	None identified in project specific areas.

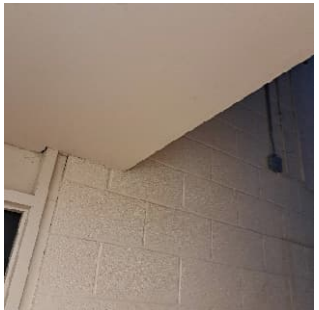
Drywall Joint Compound	Drywall joint compound was observed in the project specific areas. Bulk samples were collected during the assessment and results of analysis confirmed that this building material is not asbestos-containing. Refer to sample set 1 in Table 2.

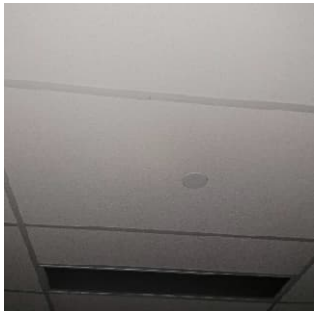
<b>Ceiling Tiles</b>	<b>Location/Description</b>	
Lay-in Acoustic Ceiling Tiles	2x4 small pinhole lay-in ceiling tiles were observed in the project specific areas. This building material was noted to contain a manufacturer's date stamp following the year 2000 and therefore is not suspected to contain asbestos.

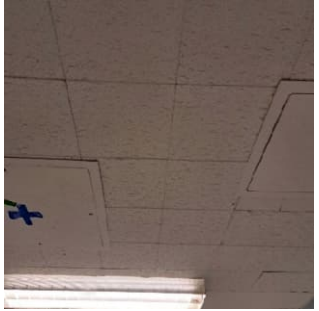
Glued-on Acoustic Ceiling Tiles	1x1 Fissure & pinhole glued-on acoustical ceiling tiles were observed in the project specific areas. Bulk samples were collected during the assessment and results of analysis confirmed that this building material is not asbestos-containing. Refer to sample set 2 in Table 2.

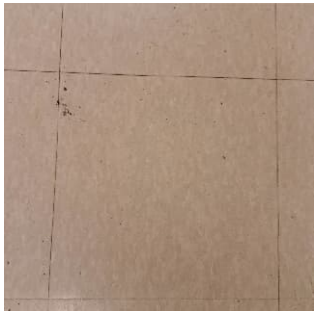
<b>Flooring</b>	<b>Location/Description</b>	
Vinyl Floor Tiles	Cream with white speck vinyl floor tiles were observed in the project specific areas. Bulk samples were collected during the assessment and results of analysis confirmed that this building material is not asbestos-containing. Refer to sample set 3 in Table 2.

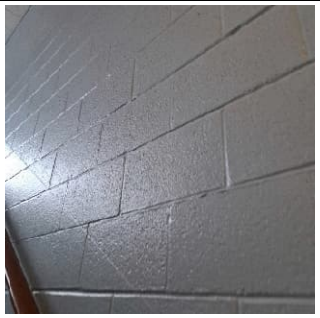
Roofing, Siding, Wallboard	None identified in project specific areas.	
Mortar	Concrete block mortar was observed in the project specific areas. Bulk samples were collected during the assessment and results of analysis confirmed that this building material is not asbestos-containing. Refer to sample set 4 in Table 2.

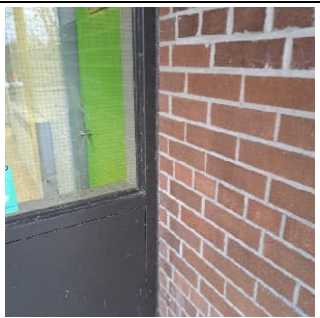
Brick mortar was observed in the project specific areas. Bulk samples were collected during the assessment and results of analysis confirmed that this building material is not asbestos-containing. Refer to sample set 5 in Table 2.

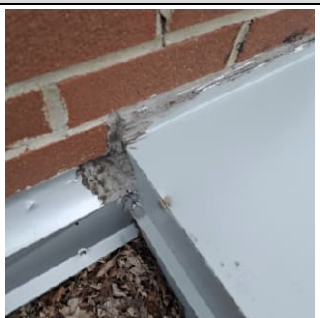
<b>Exterior Building Materials</b>	<b>Location/Description</b>	
Caulking	Grey caulking on flashing was observed in the project specific areas. Bulk samples were collected during the assessment and results of analysis confirmed that this building material is not asbestos-containing. Refer to sample set 6 in Table 2.

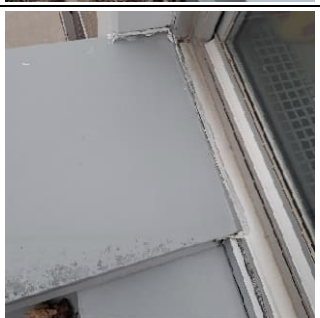
White caulking on flashing was observed in the project specific areas. Bulk samples were collected during the assessment and results of analysis confirmed that this building material is not asbestos-containing. Refer to sample set 7 in Table 2.

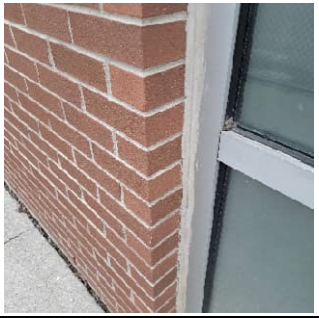
Caulking	Grey window frame caulking was observed in the project specific areas. Bulk samples were collected during the assessment and results of analysis confirmed that this building material is not asbestos-containing. Refer to sample set 8 in Table 2.

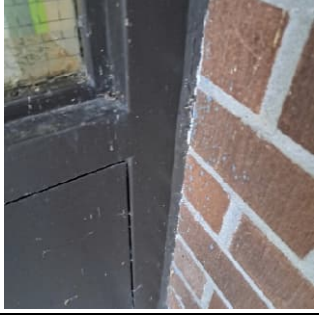
Brown door frame caulking was observed in the project specific areas. Bulk samples were collected during the assessment and results of analysis confirmed that this building material is not asbestos-containing. Refer to sample set 9 in Table 2.

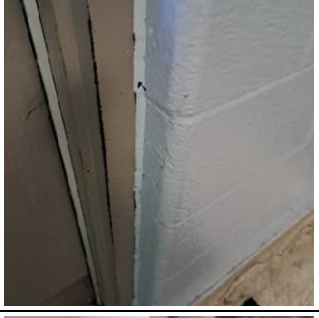
Black interior door frame caulking was observed in the project specific areas. Bulk samples were collected during the assessment and results of analysis confirmed that this building material is not asbestos-containing. Refer to sample set 10 in Table 2.

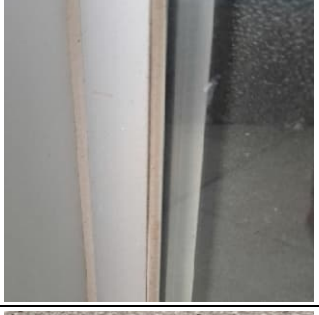
Glazing	New window glazing was observed in the project specific areas. Bulk samples were collected during the assessment and results of analysis confirmed that this building material is not asbestos-containing. Refer to sample set 11 in Table 2.

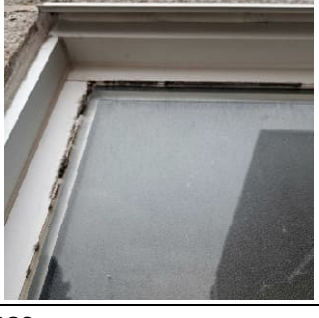
Old window glazing was observed in the project specific areas. Bulk samples were collected during the assessment and results of analysis confirmed that this building material is not asbestos-containing. Refer to sample set 12 in Table 2.

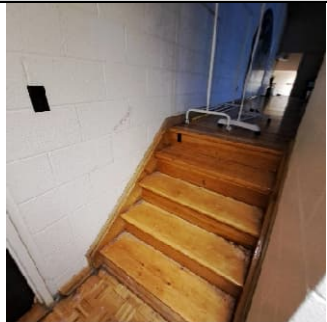
Location/Description	Picture
Cream paint associated with concrete block wall at stage door 2 (31280) was sampled during our investigation. Results of analysis indicated the presence of 0.011% concentrations of lead. Therefore, the cream paint is considered to be low-level lead paint. Refer to sample L1 in Table 4.

At this time the method of disturbance, if any, of lead-containing materials is unknown. It is recommended that any contractor whose work requires lead-containing materials to be disturbed consult the EACC or Ontario MLITSD guidelines prior to the start of work to determine the Class/Type of operation(s) and the corresponding control measures (engineering controls, work/hygiene practices, protective clothing and equipment and worker training) necessary to conduct the work in a manner that will prevent worker overexposure to lead. The following table outlines the classification of lead disturbance based on the EACC guideline.

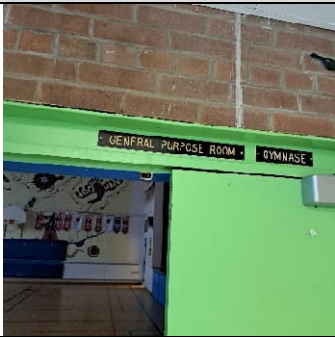
Location/Description	Picture
<p>Green paint associated with wood door at stage door 2 (31280) was sampled during our investigation. Results of analysis indicated the presence of 0.018% concentrations of lead. Therefore, the green paint is considered to be low-level lead paint. Refer to sample L2 in Table 4.</p>

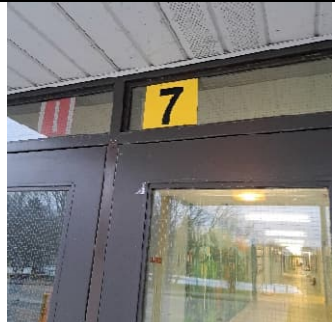
<p>Brown paint associated with exterior door 7 (31311-1) was sampled during our investigation. Results of analysis did not indicate the presence of any detectable concentrations of lead. Therefore, the brown paint is not considered to be lead-containing. Refer to sample L3 in Table 4.</p>
