Designated Substance and Hazardous Materials Survey – Pre-Renovation

City Hall, Level 4, Barrie, Ontario

October 2, 2025

Arcadis Project No. 30292342

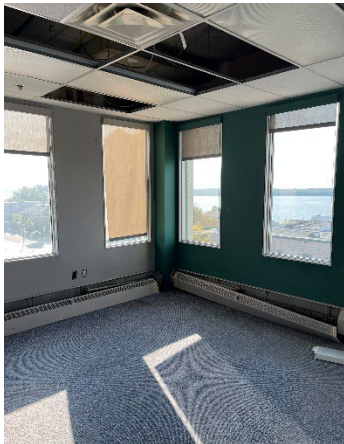
Drywall with drywall joint compound (DWJC) is present as a wall and ceiling finish throughout Level 4. The DWJC was sampled and determined to be asbestos-containing (Samples 1-A to 1-G). Drywall joint compound is considered to be non-friable and is in good condition. There are approximately 1,200 square metres of drywall with drywall joint compound.

Photograph 1 – Room 430 showing typical drywall walls with asbestos-containing drywall joint compound.

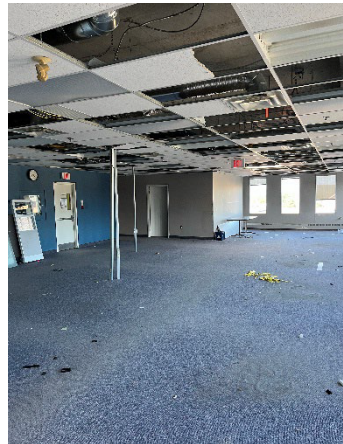
One type of vinyl floor tile (VFT) was observed below carpeting in Room 418. The tiles and mastic were sampled (Samples 6-A to 6-C). The tiles were determined to be asbestos-containing. There are approximately 12 square metres of vinyl floor tiles in Room 418. The tiles are installed over a cement substrate. The leveler was sampled and was determined to be non-asbestos. The vinyl floor tiles and mastic/leveler are non-friable and are in good condition.

Photograph 2 – North Open Area. Room 418 (at top of picture) has vinyl asbestos tiles below carpet.

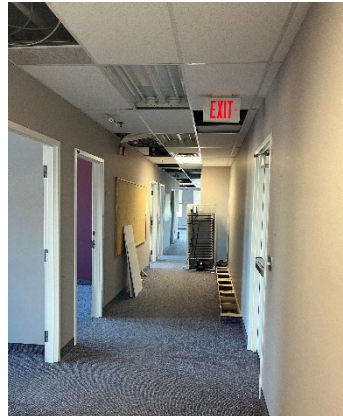
Halocarbon-Containing Equipment: A refrigerator was observed in the corridor near Room 416.

Photograph 4 – Corridor at Room 416 showing refrigerator.

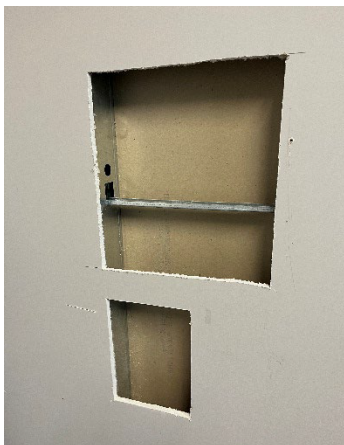
Photograph 5 – Typical space between drywall walls.

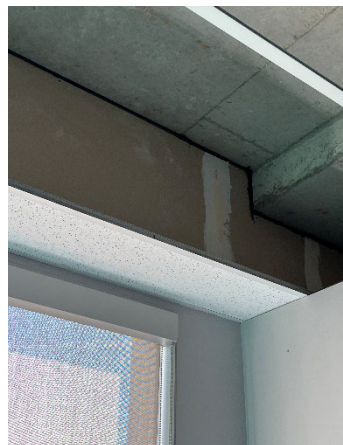
Black tar/caulking was observed along the upper perimeter of Level 4. The tar/caulking was sampled and determined to be asbestos-containing (Samples 4-A to 4-C). The tar/caulking is non-friable and is in good condition. There is approximately 120 linear metres of caulking present.

Photograph 6 – Asbestos-containing black tar/caulking.
